INSTRUCCIONES DE MONTAJE – MOUNTING INSTRUCTIONS – MONTAGEANLEITUNG

GUARDABARROS TRASERO ADAPTABLE A - REAR MUDGUARD ADAPTABLE TO - HINTERRADABDECKUNG FÜR

TRIUMPH TIGER EXPLORER '12-'15

Ref.: 6465

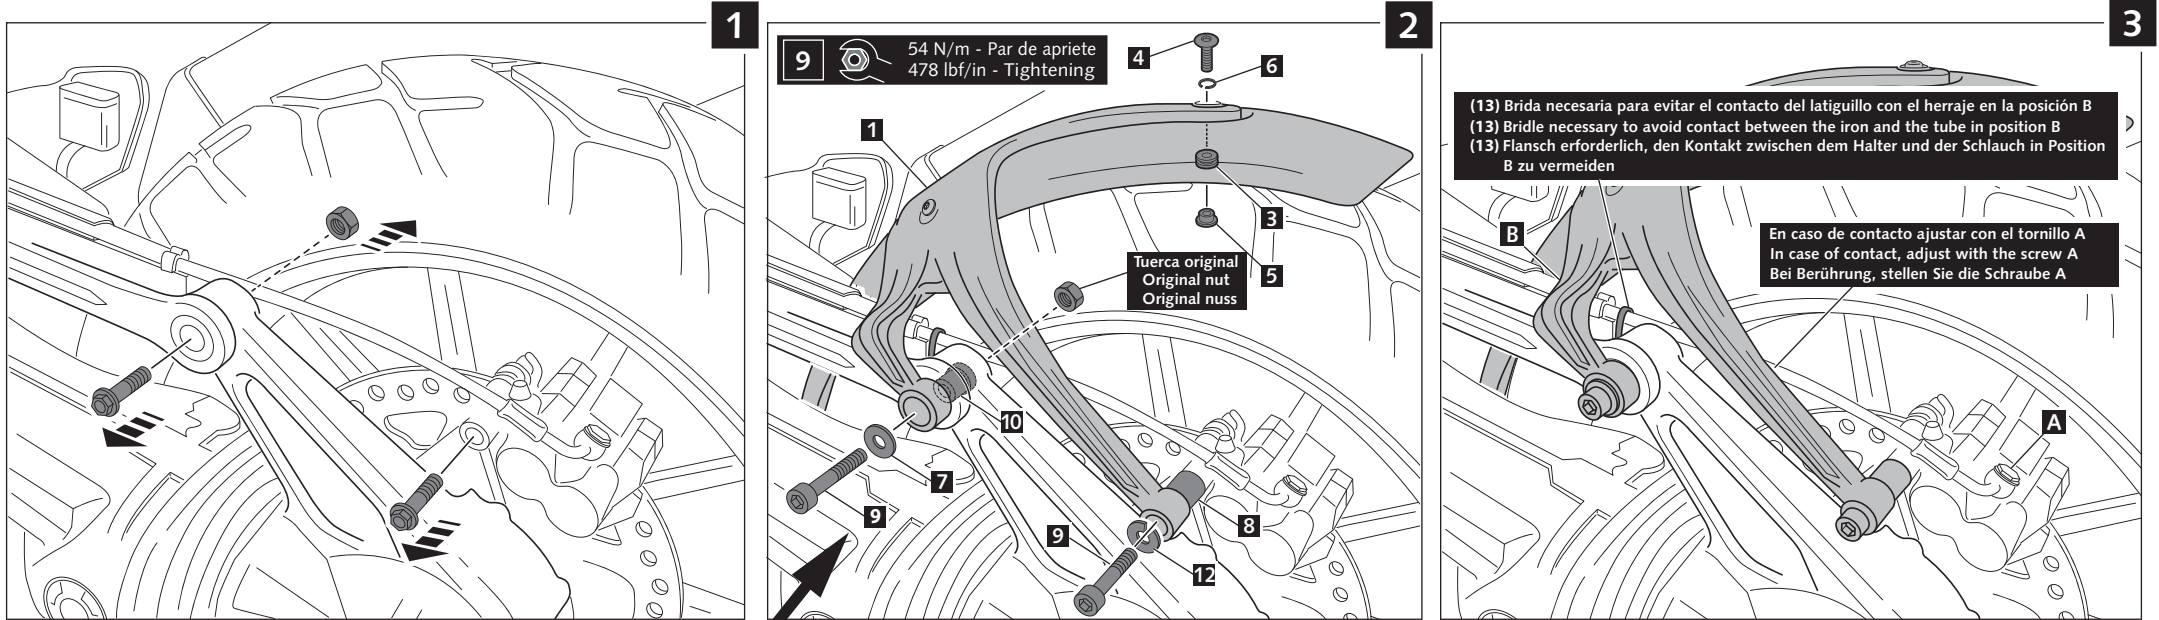
9 54 N/m - Par de apriete
478 lbf/in - Tightening

1 3
Tuerca original
Original nut
Original nuss

ATENCIÓN: El montaje del casquillo (10) en sentido contrario puede provocar la rotura del soporte (2).

ATTENTION: The assembly of the arrowhead (10) in the opposite direction can cause breakage of the support (2).
